DEPARTMENT OF TRANSPORTATION

Quality Assurance and Source Inspection

Contract #: 04-0120F4Cty: SF/ALA Rte: 80 PM: 13.2/13.9File #: 1.28**WELDING INSPECTION REPORT****Resident Engineer:** Casey, William**Address:** 333 Burma Road**City:** Oakland, CA 94607**Report No:** WIR-027714**Date Inspected:** 05-Jun-2012**Project Name:** SAS Superstructure**OSM Arrival Time:** 700**Prime Contractor:** American Bridge/Fluor Enterprises, a JV**OSM Departure Time:** 1930**Contractor:** American Bridge/Fluor Enterprises, a JV**Location:** Job site**CWI Name:** As Noted Below**CWI Present:** Yes No**Inspected CWI report:** Yes No N/A**Rod Oven in Use:** Yes No N/A**Electrode to specification:** Yes No N/A**Weld Procedures Followed:** Yes No N/A**Qualified Welders:** Yes No N/A**Verified Joint Fit-up:** Yes No N/A**Approved Drawings:** Yes No N/A**Approved WPS:** Yes No N/A**Delayed / Cancelled:** Yes No N/A**Bridge No:** 34-0006**Component:** OBG/Tower**Summary of Items Observed:**

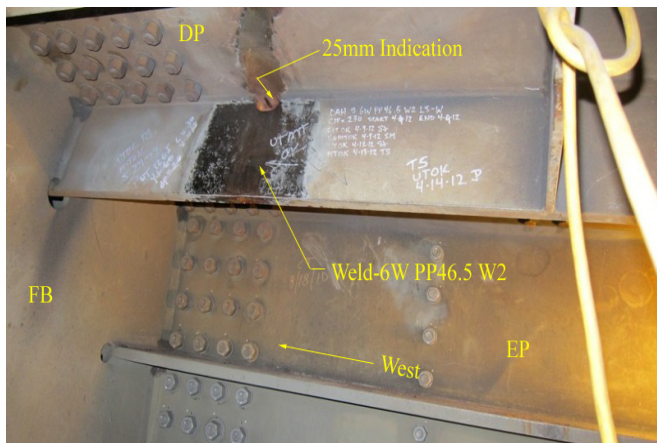
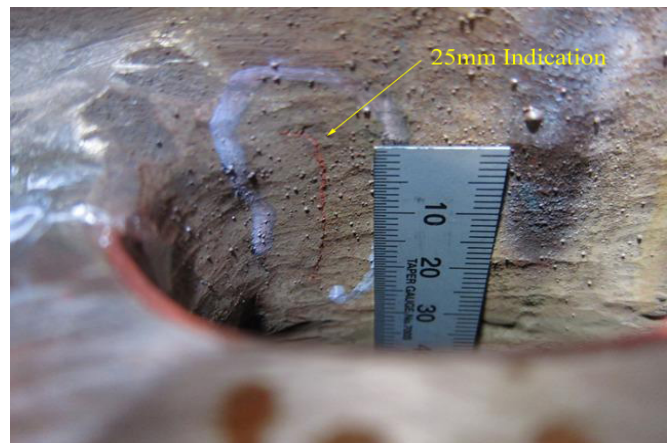
During verification Visual Inspection (VT) a total of one (1) linear indication measuring a total of 25mm was observed with residual magnetic particles in way of the rib stiffener cut out termination adjacent the weld being tested (See below photographs). The Smith Emery QC Lead Mr. Bonifacio Daquinag JR. was notified who then

stated that Caltrans QA would be notified after the indication was ground out and re-inspected.
